# Carriage Wheel Assembly Upgrades & Modifications

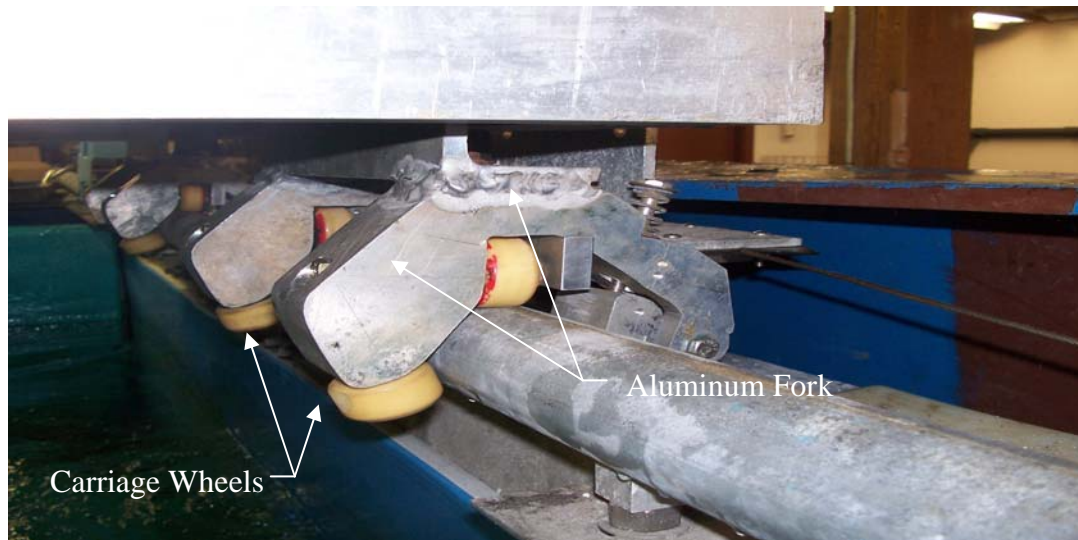
*Figure 1. Fork Truck Assembly*

The carriage wheel assembly consists of an aluminum fork in which six skateboard wheels are connected. This allows for support in all directions to ensure stable, smooth motion. A fork is located at all four corners of the rectangular carriage.

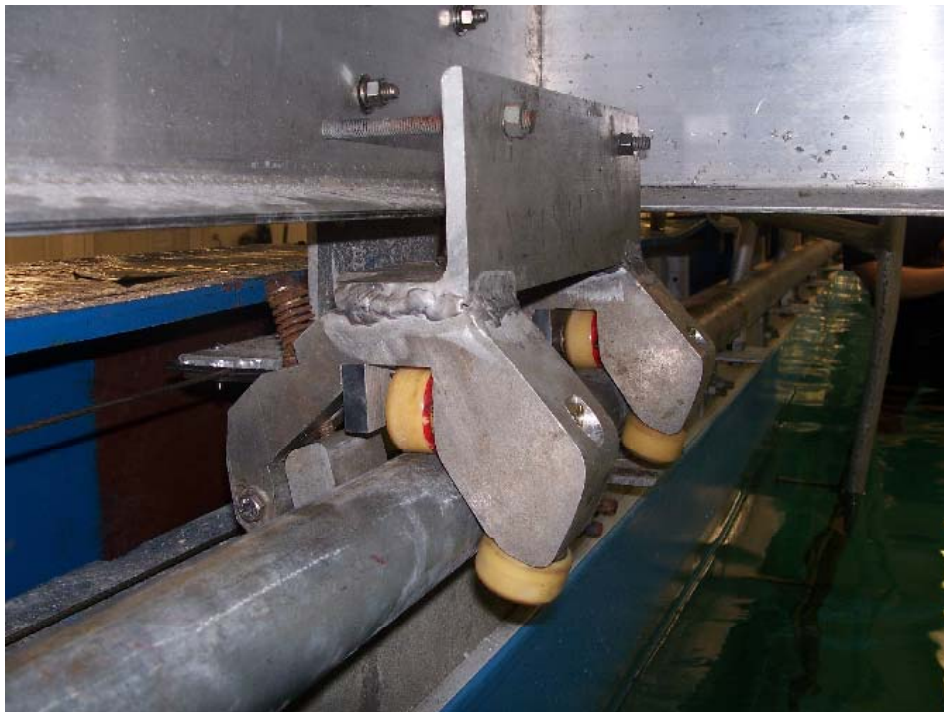
*Figure 7. Complete Truck Installed On Carriage*

These modifications allow for the carriage to provide accurate and reliable data test after test for years to come. The completed truck with all the modifications is shown in the pictures below.
